# 18 YEARS LATER AND STILL GOING STRONG

Galvanic Cathodic Protection  
Extends Service Life of  
Ohio DOT Bridge Substructures

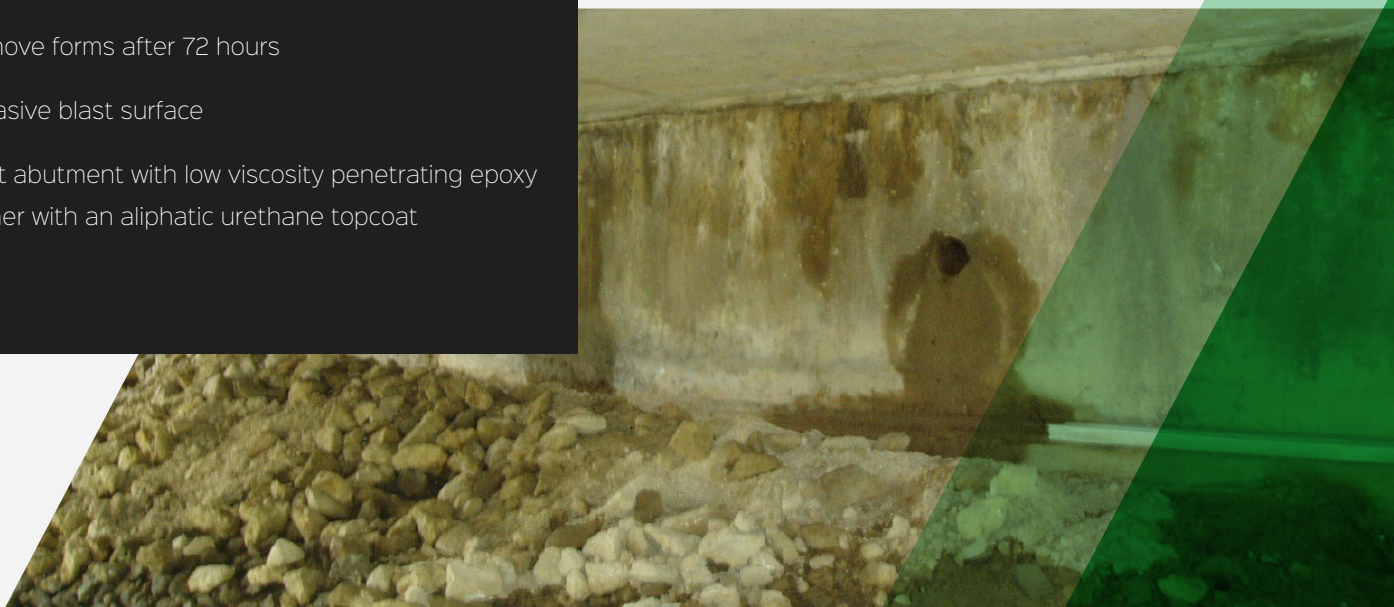
**Figure 1 – Abutment condition prior to repair, May 2005**

It has become common on these slab bridges for the abutments to experience concrete damage and deterioration. Corrosion was the cause of failing abutments due to the deck joint being directly over the abutment. The joint seals would fail, allowing deicing salt, grit and water to enter the joint and contaminate the abutment stem wall. These typical 1950's vintage slab bridges would have a 19 to 22 inches thick slab cast into a key joint in the top of the abutment. As the deck would cool in the winter, thermal contraction would put tension on the key as it pulled the abutment stem walls toward each other.

This likely initiated a crack at the base of the key that accelerated salt contamination of the stem wall reinforcing. Once corrosion started, the top of the stem wall would spall.

Figure 1 shows the condition of the abutment prior to concrete removal. Figures 2 and 3 illustrate the repair strategy. Figure 6 shows the formwork just prior to casting, and Figure 7 shows the completed repair.

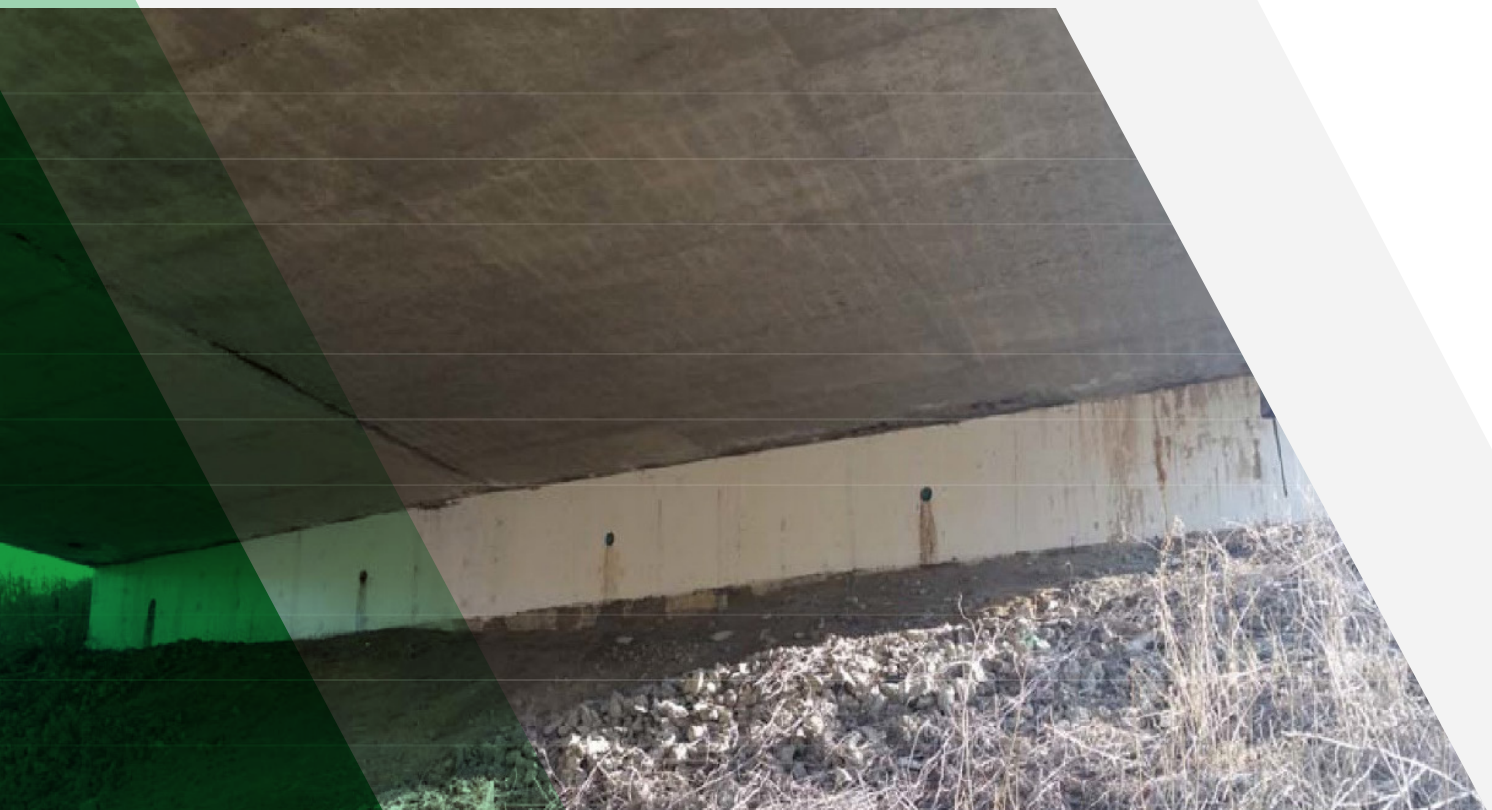
Over the last 18 years the bridges included in the ODOT refacing experiment have performed remarkably well. The joint seals have failed and were replaced, but the abutments are still in good shape. There are signs of water seepage as evidenced by the calcified deposits in Figure 8. This strategy has now eliminated two full 7-year repair cycles and it appears that the repaired abutment has many more years of service.

**Figure 8** – Abutment of I-75 Bridge over Kirkwood Road (mm 87) in 2022  
(Note efflorescence from leaking joint and weep holes)
