## Repairing and Protecting Concrete Piles with Galvanic Jackets

by J. Christopher Ball, Vector Corrosion Services

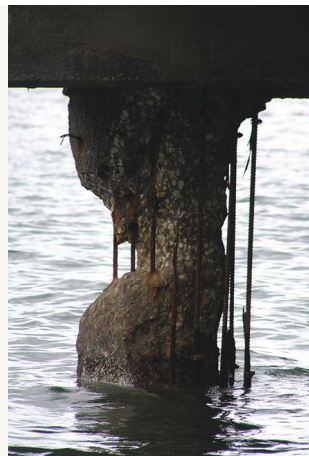
Figure 1. Corrosion of prestressed pile in tidal/splash zone. All Photos and Figures: Vector Corrosion.

- Atmospheric (Dry)—elevated sections of concrete piles are subject to airborne chloride deposition. Once critical concentrations of chloride are present on the steel surface, the passive oxide layer is defeated and corrosion initiates.
- Splash/tidal (Wet/Dry)—the splash and tidal zones are intermittently subjected to seawater saturation and are at high risk of corrosion due to wet-dry chloride exposure cycles.
- Submerged (Wet)—underwater sections of piles are less frequently affected by corrosion damage. This is due to seawater having low levels of dissolved oxygen, a precondition for corrosion because oxygen is necessary at the cathodic sites to facilitate the reduction reaction ( $O_2 + 2H_2O + 4e^- \rightarrow 4OH^-$ ).

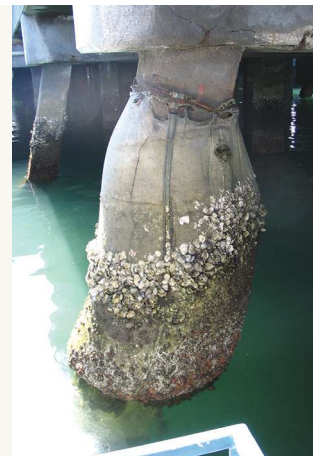
Figure 2. Fabric form jacket with concrete fill.

- an overbuilt layer of reinforced concrete,
- cement-grout-filled stay-in-place forms (fiber-reinforced polymer [FRP], corrugated steel, or fabric), or
- epoxy-grout-filled FRP jackets.

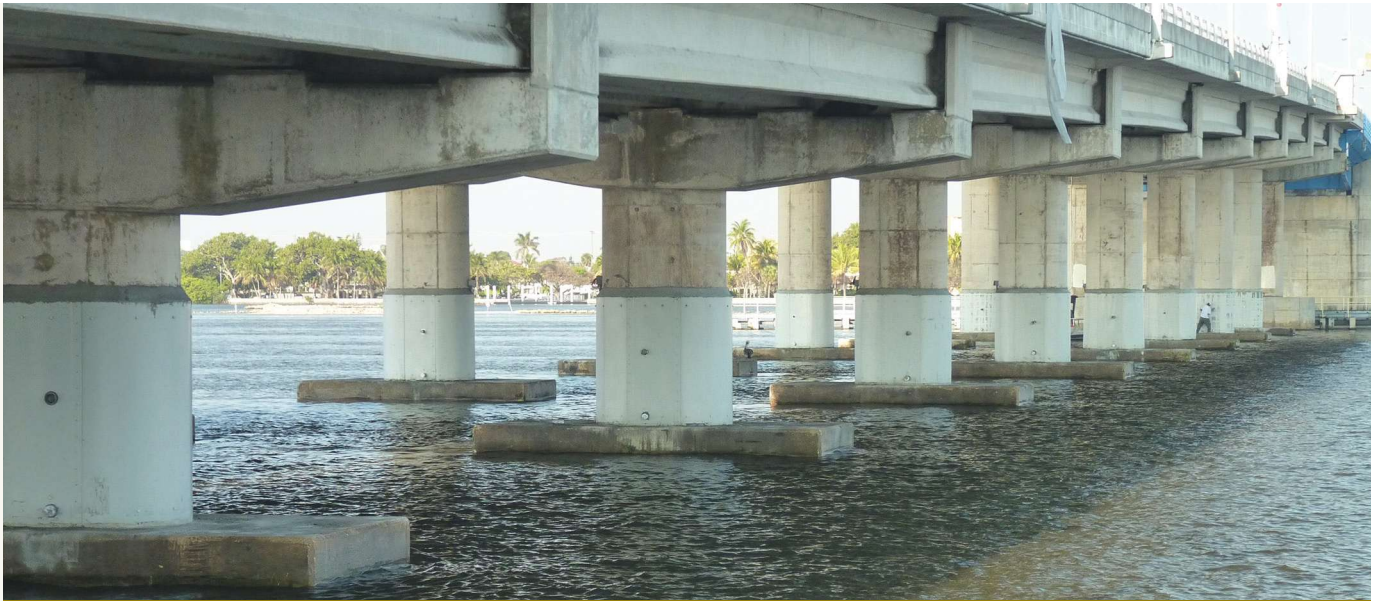
Figure 5. Installed dry jacket system that includes galvanic jackets with activated anodes (no bulk anodes).

A different type of galvanic jacket uses premanufactured self-activated anodes (AA) placed inside stay-in-place forms with portland cement grout or concrete infill. Self-activated anodes (that is, not saltwater/chloride activated) function by keeping the zinc in a highly alkaline environment that is corrosive to zinc but not to reinforcing steel. This technology facilitates anode operation independent of exposure to seawater or chloride saturation (Fig. 5) and can be used in dry applications (that is, dry jacket) such as severely damaged bridge columns or piles above high tide. If the concrete section to be protected is only in a dry, atmospherically exposed area, then a dry

jacket with activated anodes is necessary but bulk zinc anodes are not required.

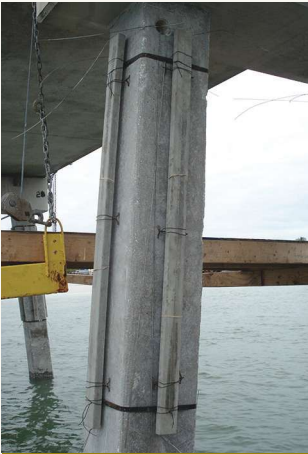
Figure 6. Dry jacket that includes alkali-activated anodes on the pile prior to jacketing (bulk zinc anode not shown).

adjusted based on the desired service life. The anodes can be installed directly onto the pile or attached to stay-in-place formwork (Fig. 6). The anodes are used with a variety of formwork including removable concrete forms, stay-in-place FRP, or modular PVC forming systems that are assembled in the field (Fig. 7).

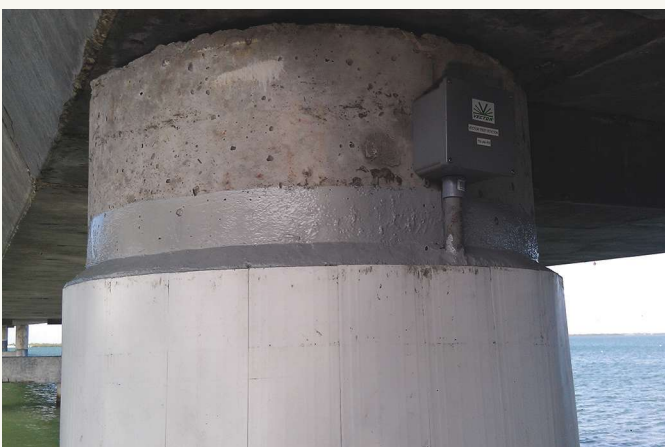
Figure 7. Self-activated anodes inside modular PVC formwork.
